# Home Report

7 LINNHE CRESCENT, PATHER, WISHAW, ML2 0NX

**Dwelling type:** Mid-terrace house  
**Date of assessment:** 21 September 2022  
**Date of certificate:** 25 September 2022  
**Total floor area:** 80 m<sup>2</sup>  
**Primary Energy Indicator:** 279 kWh/m<sup>2</sup>/year

# Scottish Single Survey

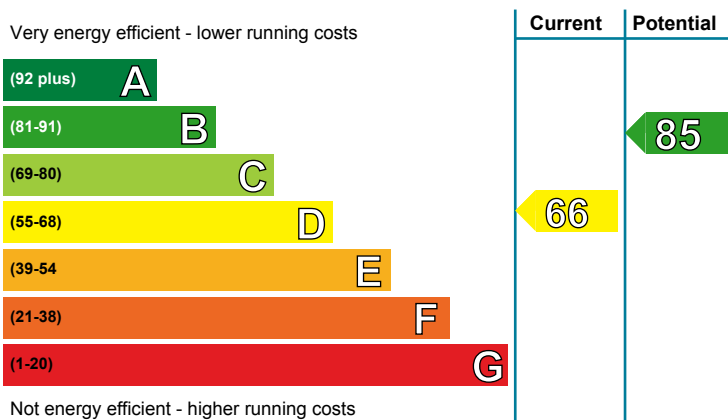
## Energy Efficiency Rating

This graph shows the current efficiency of your home, taking into account both energy efficiency and fuel costs. The higher this rating, the lower your fuel bills are likely to be.

Your current rating is **band D (66)**. The average rating for EPCs in Scotland is **band D (61)**.

The potential rating shows the effect of undertaking all of the improvement measures listed within your recommendations report.

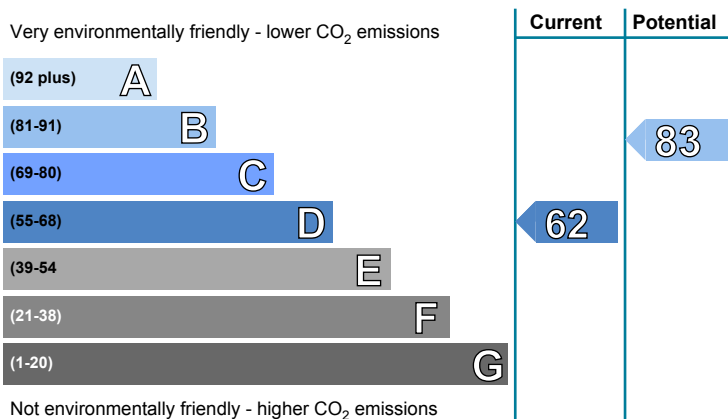
## Environmental Impact (CO<sub>2</sub>) Rating

This graph shows the effect of your home on the environment in terms of carbon dioxide (CO<sub>2</sub>) emissions. The higher the rating, the less impact it has on the environment.

The potential rating shows the effect of undertaking all of the improvement measures listed within your recommendations report.
