HOME REPORT

49 DERVAIG GARDENS
LONGRIGGEND
AIRDRIE
ML6 7TN

Energy Performance Certificate (EPC)

49 DERVAIG GARDENS, LONGRIGGEND, AIRDRIE, ML6 7TN

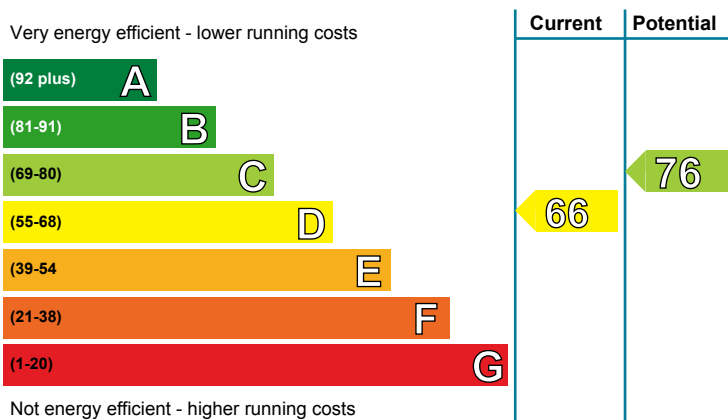
Energy Efficiency Rating

This graph shows the current efficiency of your home, taking into account both energy efficiency and fuel costs. The higher this rating, the lower your fuel bills are likely to be.

Your current rating is **band D (66)**. The average rating for EPCs in Scotland is **band D (61)**.

The potential rating shows the effect of undertaking all of the improvement measures listed within your recommendations report.

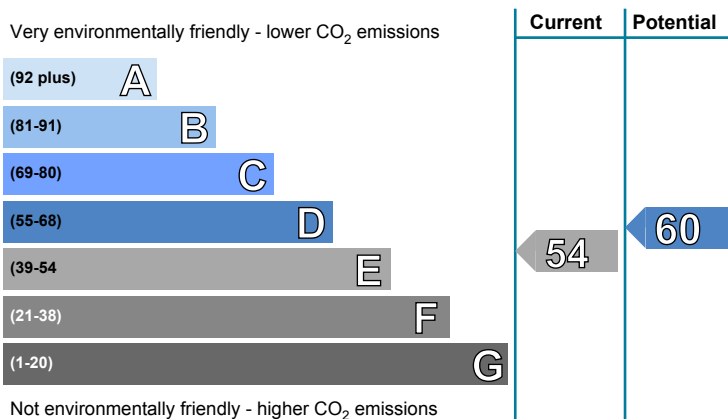
Environmental Impact (CO₂) Rating

This graph shows the effect of your home on the environment in terms of carbon dioxide (CO₂) emissions. The higher the rating, the less impact it has on the environment.

Your current rating is **band E (54)**. The average rating for EPCs in Scotland is **band D (59)**.

The potential rating shows the effect of undertaking all of the improvement measures listed within your recommendations report.
